TDD Number: 13-08-0020 Photographed by: Carl Overpeck

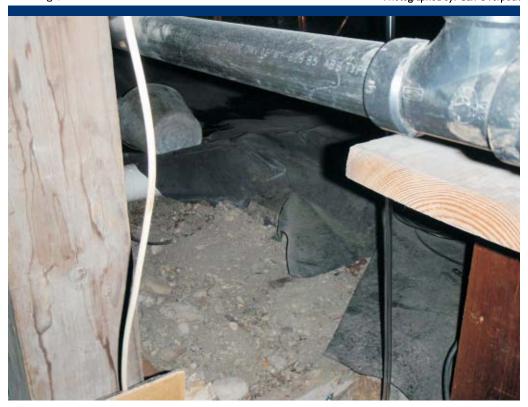
Photo 7 Exposed gravel beneath crawl space liner.

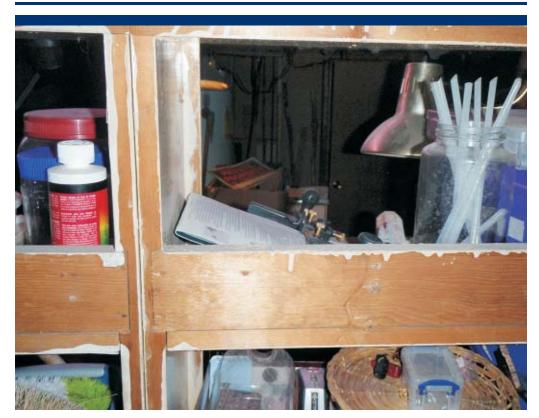
Photo 8 North room looking into work shop shelves.

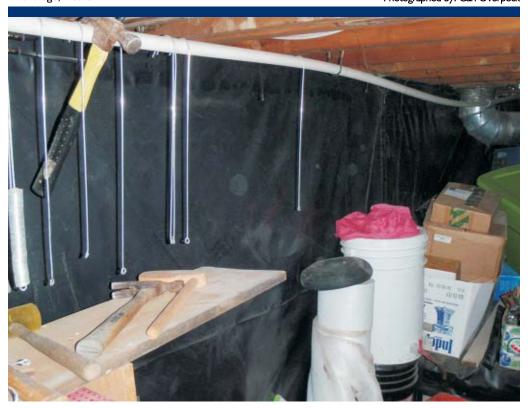
Photo 11 Lined west wall.

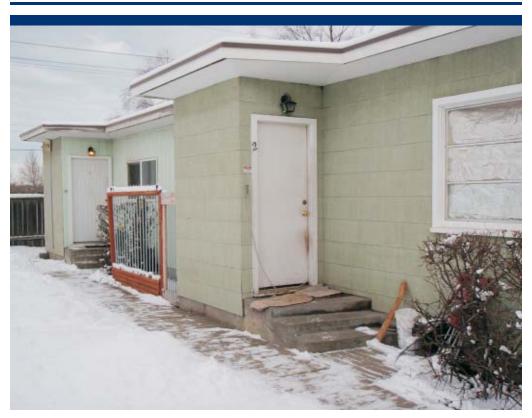
Photo 20 736 East 3rd Avenue North Duplex.
